# PRESTON AIRPORT

Using the branch, section and sample unit divisions established, a visual condition survey was conducted at Preston Airport on November 04, 2006. During the inspection pavement defects were identified and measured in accordance with the methodology outlined in FAA AC:150/5380-6 and ASTM D5430. Our inspection ensures your airport complies with the “detailed inspection” requirement of FAA’s PMMP guidelines. After collection, the data were entered into the Micro PAVER software for analysis. These data are reproduced in the Re-Inspection Report attached in Appendix 2. Photographs of typical distresses observed during the inspections are provided in Appendix 3.

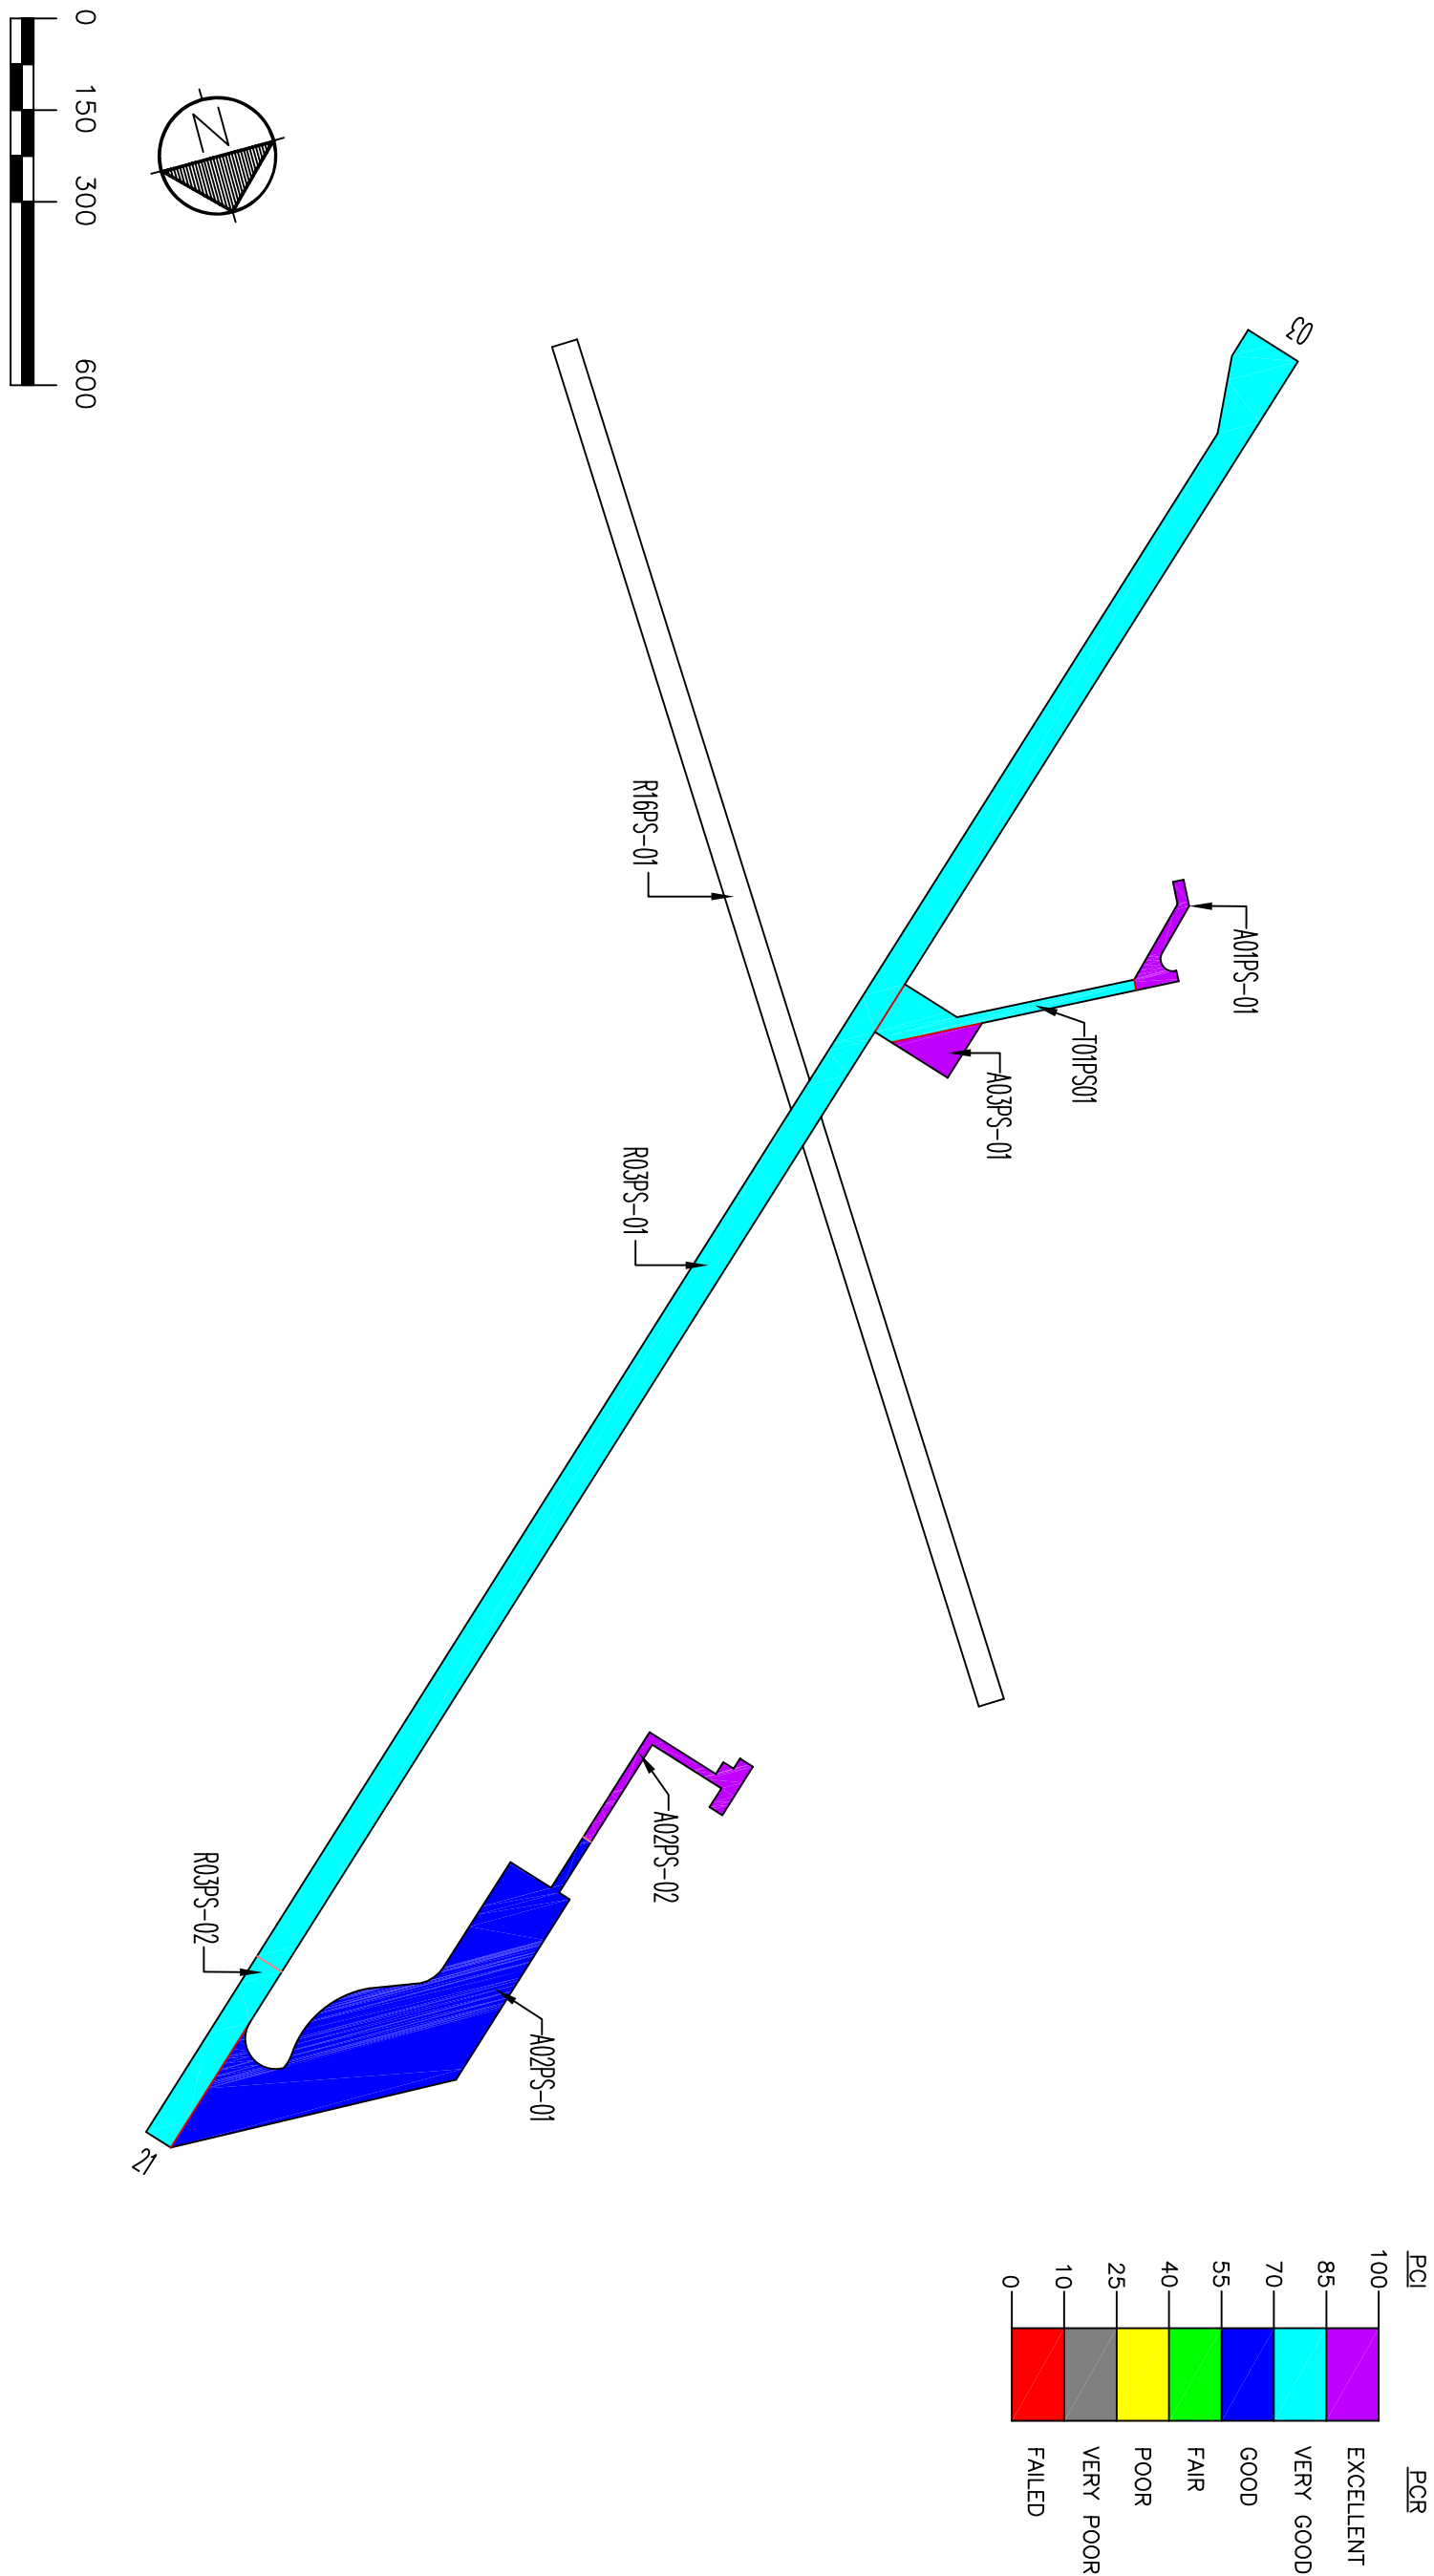
Figure PS-3. Pavement Condition in 2006.  
Preston Airport

Section PCIs at the airport range from a low of 67 (a PCR of “Good”) to a high of 96 (a PCR of “Excellent”). The area-weighted average PCI for all airport pavements is 76, corresponding to an overall PCR of “Very Good”. Figure PS-4 shows how much pavement area is associated with each Pavement Condition Rating category and also shows pavement condition distribution from the inspections conducted in 1996 and 1999. A graphical representation of the projected PCRs presented in Table PS-2 is shown in Figure PS-5.

The primary distresses observed during the inspection were longitudinal and transverse cracking, alligator cracking, and block cracking with isolated occurrences of depression, rutting and weathering/raveling.

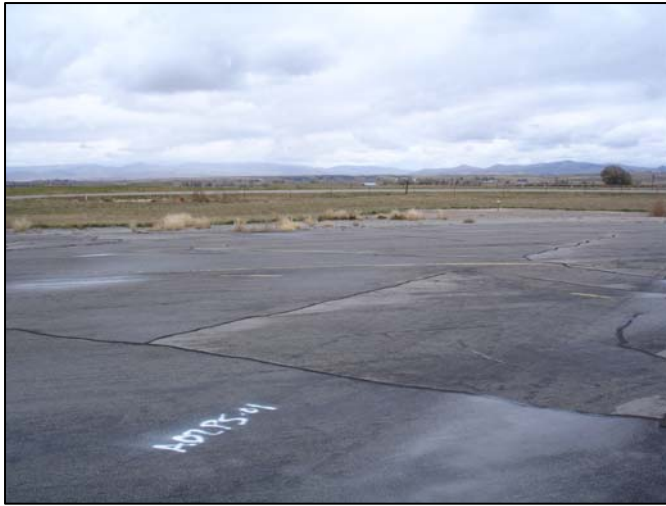
Sample Number: 03 Type: R Area: 5,000.00SqFt PCI = 67  
43 BLOCK CRACKING L 94.00 SqFt  
45 DEPRESSION L 50.00 SqFt  
48 LONGITUDINAL/TRANSVERSE CRACKING L 474.12 Ft

Sample Number: 04 Type: R Area: 5,000.00SqFt PCI = 73  
43 BLOCK CRACKING L 168.00 SqFt  
48 LONGITUDINAL/TRANSVERSE CRACKING L 464.12 Ft

Sample Number: 05 Type: R Area: 5,000.00SqFt PCI = 77  
48 LONGITUDINAL/TRANSVERSE CRACKING L 504.13 Ft

Sample Number: 08 Type: R Area: 5,000.00SqFt PCI = 40  
41 ALLIGATOR CRACKING L 699.99 SqFt  
48 LONGITUDINAL/TRANSVERSE CRACKING L 300.08 Ft  
48 LONGITUDINAL/TRANSVERSE CRACKING M 31.01 Ft  
52 WEATHERING/RAVELING L 80.00 SqFt

Sample Number: 19 Type: R Area: 5,697.00SqFt PCI = 87  
48 LONGITUDINAL/TRANSVERSE CRACKING L 231.06 Ft

Sample Number: 20 Type: R Area: 4,090.00SqFt PCI = 51  
41 ALLIGATOR CRACKING L 432.00 SqFt  
48 LONGITUDINAL/TRANSVERSE CRACKING L 305.08 Ft

Section: A02PS-01  
Longitudinal/ Transverse Cracking

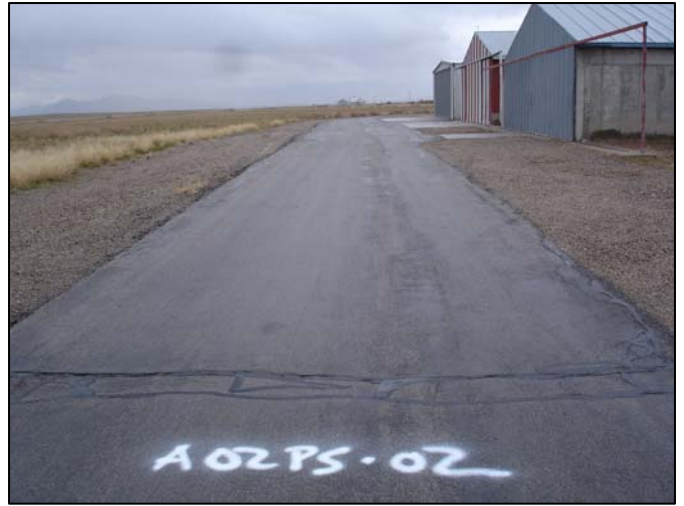
Sample Number:	01	Type:	R	Area:	4,813.00SqFt	PCI = 93
48	LONGITUDINAL/TRANSVERSE	CRACKING	L		83.02 Ft	
Sample Number:	02	Type:	R	Area:	3,045.00SqFt	PCI = 86
48	LONGITUDINAL/TRANSVERSE	CRACKING	L		142.04 Ft

Section: A02PS-02  
Longitudinal/ Transverse Cracking

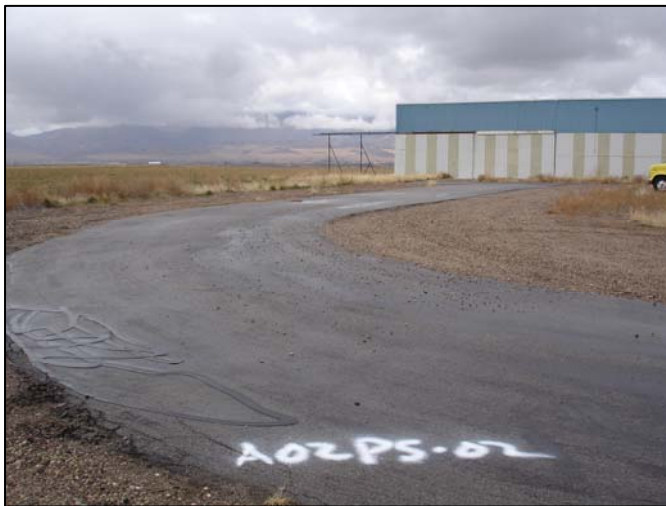
Section: A02PS-02  
Longitudinal/ Transverse Cracking

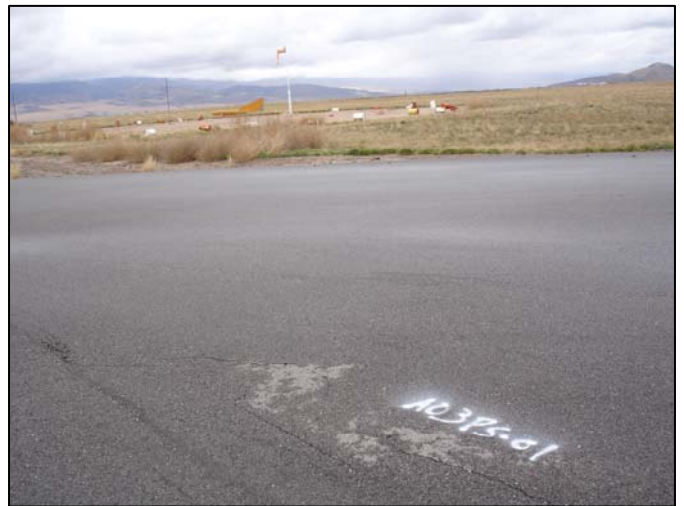
Sample Number:	01	Type:	R	Area:	5,766.00SqFt	PCI = 94
48	LONGITUDINAL/TRANSVERSE	CRACKING	L		81.02 Ft

Section: A03PS-01  
Longitudinal/ Transverse Cracking

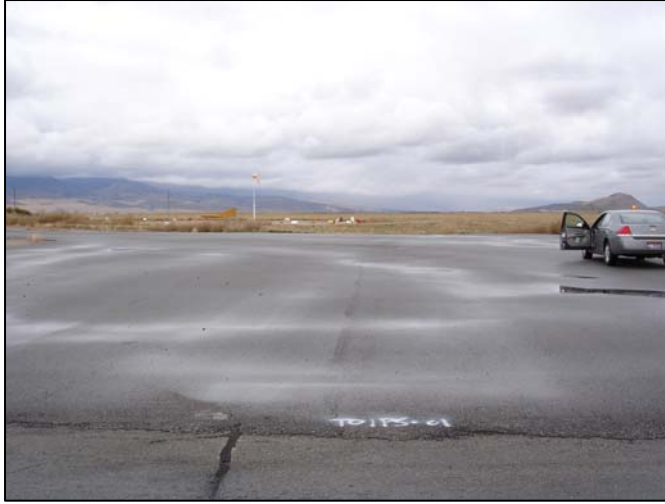
Sample Number:	01	Type:	R	Area:	7,137.00SqFt	PCI = 67
48	LONGITUDINAL/TRANSVERSE	CRACKING	L	10.00	Ft	
48	LONGITUDINAL/TRANSVERSE	CRACKING	M	29.01	Ft	
45	DEPRESSION		M	196.00	SqFt

Sample Number:	02	Type:	R	Area:	5,330.00SqFt	PCI = 95
48	LONGITUDINAL/TRANSVERSE	CRACKING	L	55.01	Ft

Section: T01PS-01  
Depression  
Longitudinal/ Transverse Cracking

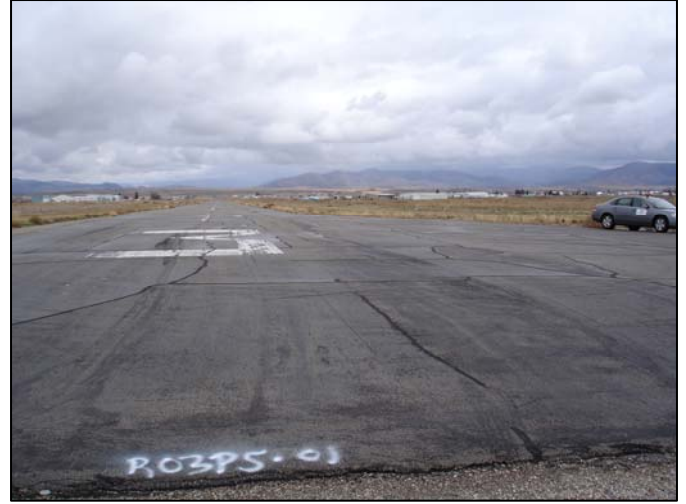
Sample Number: 01 Type: R Area: 5,280.00SqFt PCI = 77  
48 LONGITUDINAL/TRANSVERSE CRACKING L 526.13 Ft

Sample Number: 03 Type: R Area: 4,800.00SqFt PCI = 81  
48 LONGITUDINAL/TRANSVERSE CRACKING L 348.09 Ft

Sample Number: 09 Type: R Area: 4,800.00SqFt PCI = 89  
48 LONGITUDINAL/TRANSVERSE CRACKING L 167.04 Ft

Sample Number: 15 Type: R Area: 4,800.00SqFt PCI = 81  
48 LONGITUDINAL/TRANSVERSE CRACKING L 358.09 Ft

Sample Number: 21 Type: R Area: 4,800.00SqFt PCI = 81  
48 LONGITUDINAL/TRANSVERSE CRACKING L 344.09 Ft

Sample Number: 27 Type: R Area: 4,800.00SqFt PCI = 73  
48 LONGITUDINAL/TRANSVERSE CRACKING L 444.11 Ft  
53 RUTTING L 44.00 SqFt

Section: R03PS-01  
Longitudinal/ Transverse Cracking

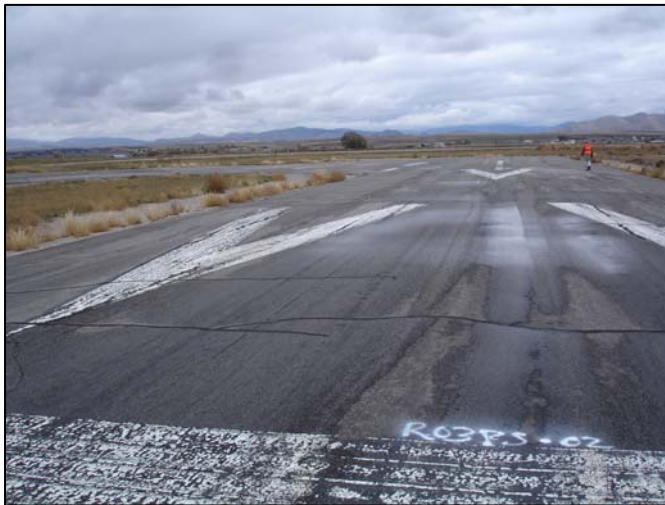
Sample Number:	01	Type:	R	Area:	4,800.00SqFt	PCI = 76
48	LONGITUDINAL/TRANSVERSE	CRACKING		L	337.09 Ft	
53	RUTTING			L	62.00 SqFt	
Sample Number:	02	Type:	R	Area:	4,800.00SqFt	PCI = 82
48	LONGITUDINAL/TRANSVERSE	CRACKING		L	277.07 Ft	
45	DEPRESSION			L	16.00 SqFt	
Sample Number:	03	Type:	R	Area:	4,800.00SqFt	PCI = 81
48	LONGITUDINAL/TRANSVERSE	CRACKING		L	352.09 Ft

Section: R03PS-02  
Longitudinal/ Transverse Cracking
